Inspection Report Minerals Regulatory Program October 1, 2009

Mine Name: Clark 1/Emeryide	Permit Number: S/015/0053
Operator Name: Robert Clark	Inspection Date: 08/20/2009
Inspector(s): Brett Gregory for Wayne Western	Time: 3:30 pm
Other Participants: None	Mine Status: Inactive

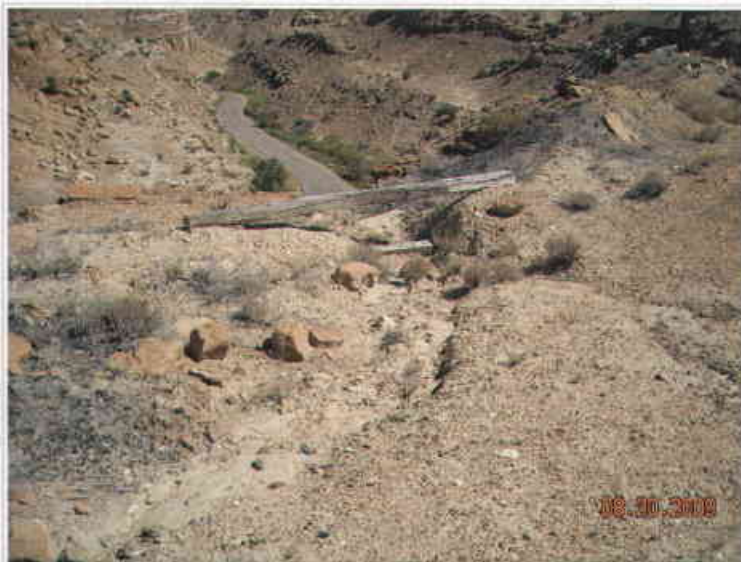
- 2) There are a few loose pieces of garbage that can be cleaned up, although nothing too significant.
- 3) A sediment trap should be constructed in one of the photographs documented below, and the other trap shown needs minor maintenance.
- 5) Deep ruts have formed on the haul road coming up from the portal. I would suggest the installation of a water bar and ditch to control runoff.

A sediment trap or something like it should be installed here.

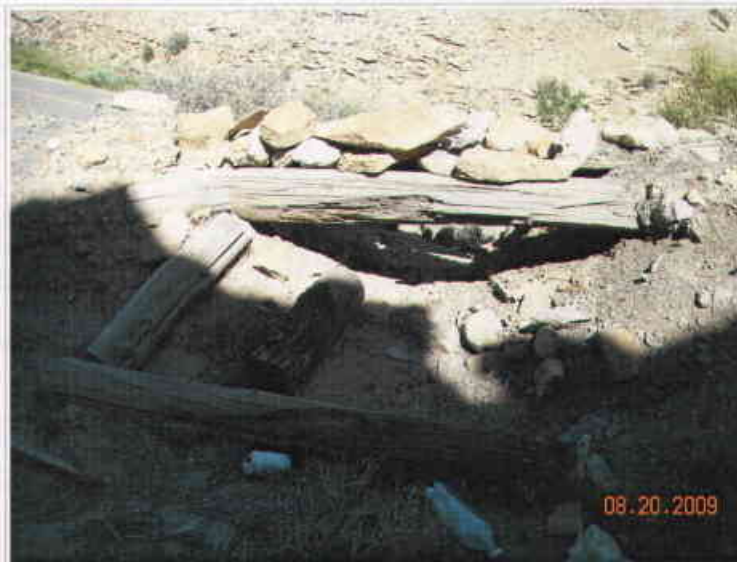
Sediment trap fallen under disrepair.

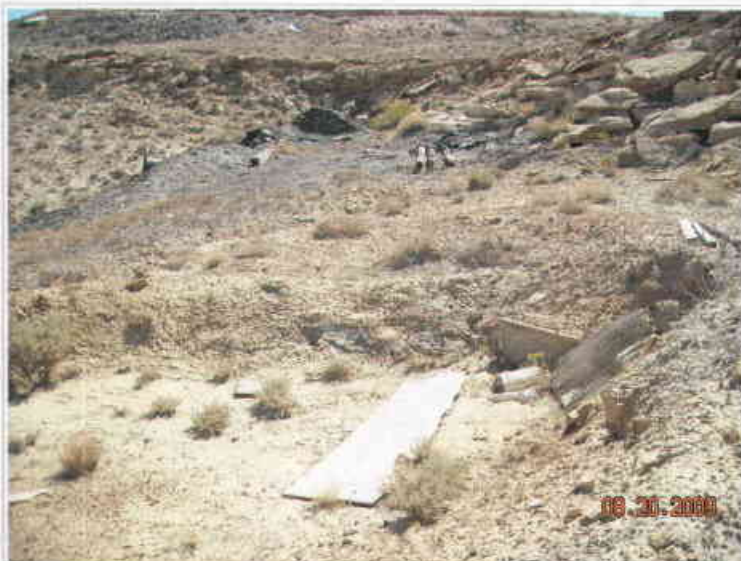
Trash can be cleaned up.

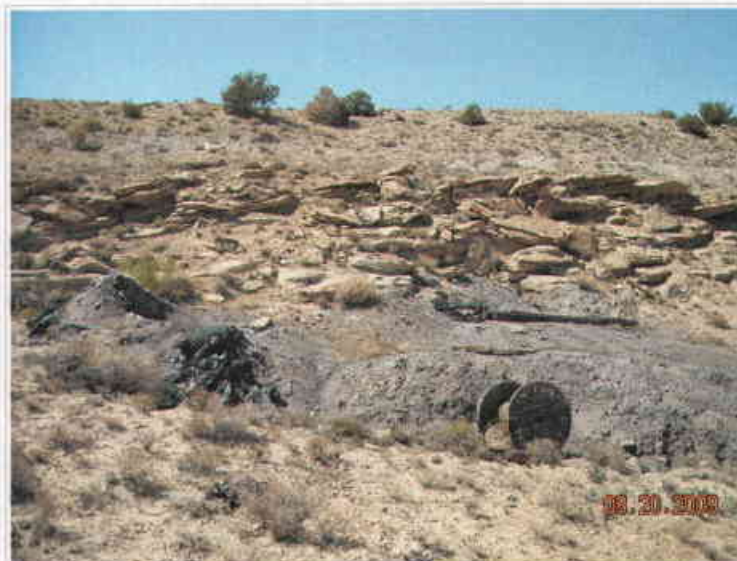
More trash.

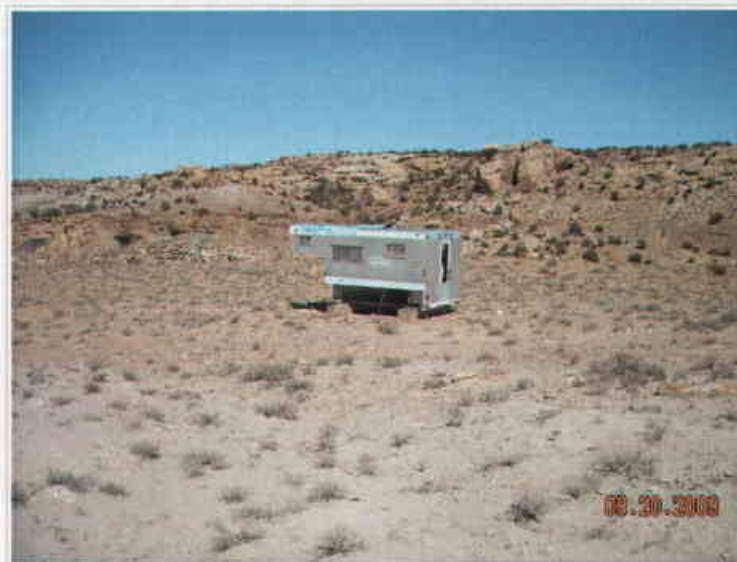
Camper left on site.

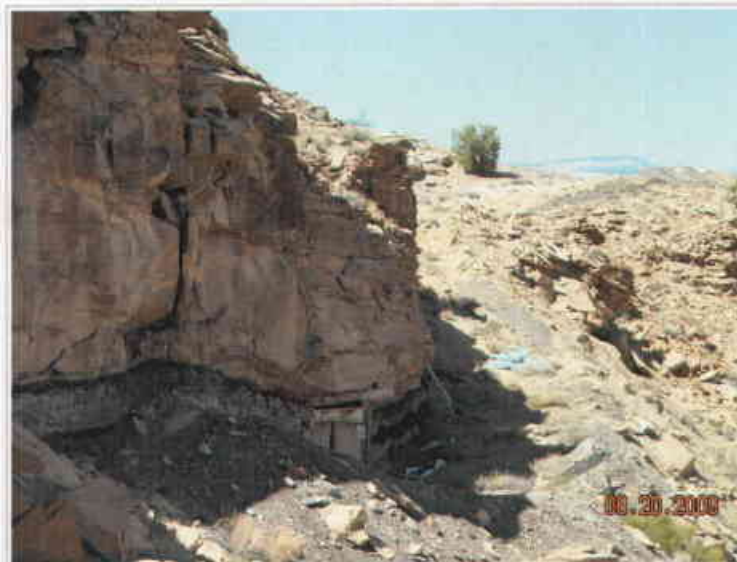
The road shown here exiting is developing deep ruts.
